NOTICE OF THE EXCAVATION OF A BROCH AT JARLSHOF, SUMBURGH,
SHETLAND. BY JOHN BRUCE OF SUMBURGH, F.S.A. SCOT.

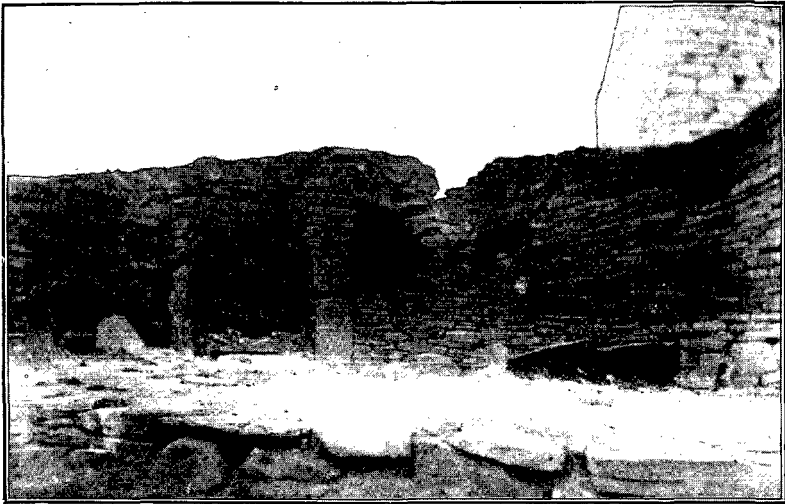
Fig. 2. Interior of the Broch.

In the centre of the mound, partly underneath the Jarlshof, was cleared out part of the interior area of a broch (fig. 2) similar to other brochs found in Shetland. Almost one half of it had been swept away by the sea; the remaining half shows the usual broch structure. The highest part of the main wall, of which an exterior view is shown in fig. 3, is about 7 feet in height. It is pierced by a passage 3 feet wide, evidently leading to a staircase, and has in its thickness several chambers. The roof of the passage, however, is gone, and the chambers, with one exception, are partly

demolished. There are two recesses or chambers, one incomplete, opening on the interior of the broch, and measuring $4\frac{1}{2}$ feet by 4 feet.

There are other two chambers in the substance of the wall; each, however, has lost about one-half of its length by the action of the sea. In one of these is a cist-like construction, measuring 3 feet by 18 inches, which is on the level of the floor of the broch, and contained nothing but earth. On the floor of the broch are several stones, disposed

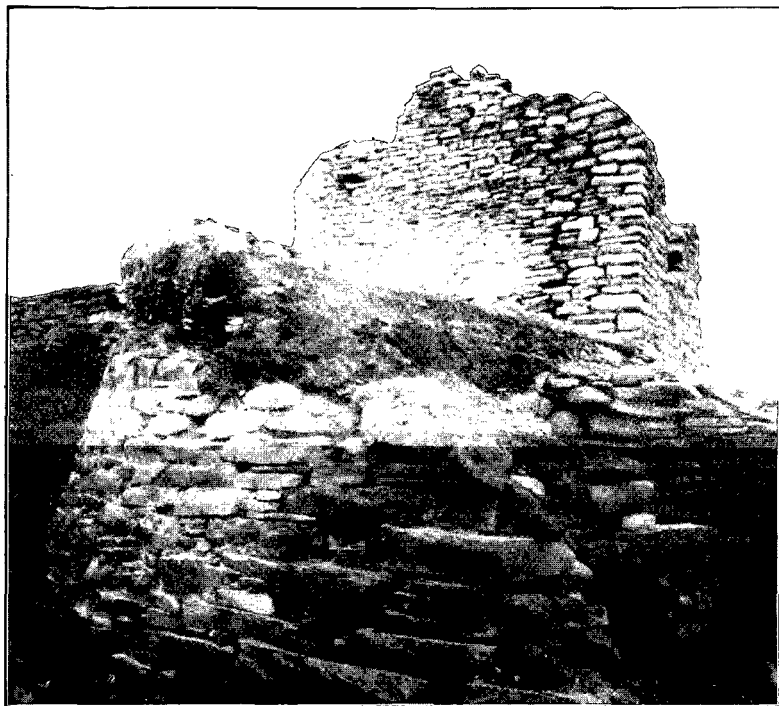
Fig. 3. Exterior View of the Main Wall of the Broch, looking from seaside,
7 feet in height.

The inner and outer faces of the wall are perfectly circular, of an outside diameter of 63 feet, of dry-built stone.

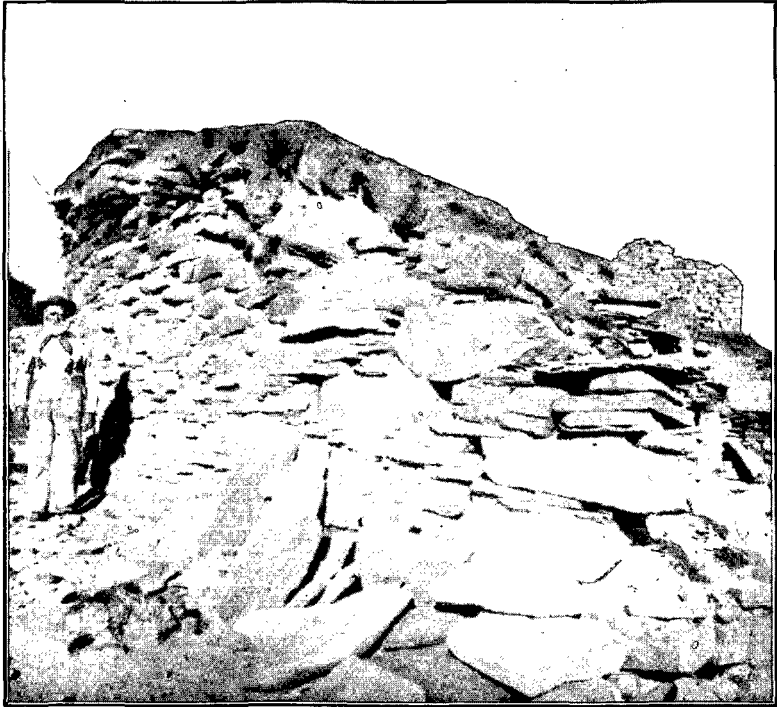
Fig. 4. Outer Main Wall, looking from seaside. Height 11 feet.

On the extreme west edge of the mound was unearthed a huge wall of dry-built stone (fig. 4), following the circle of the broch, but its

outside edge at a distance of 52 feet from it. The highest point of the wall is about 11 feet, it is at its thinnest part 10 feet thick, and in other parts several feet more, reaching at one part about 20 feet, as substantial and formidable in some parts as the main wall of the broch itself. This wall can be followed back for about 70 feet, and here it ends rather abruptly, being pierced transversely by a passage, on

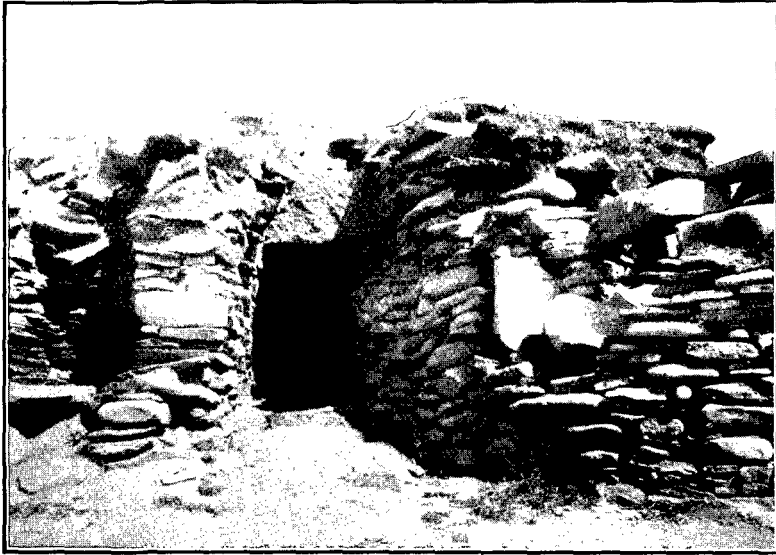
Fig. 5. Opening of Gallery or Passage in the thickness of the Outer Main Wall.
From the sea-beach.

the other side of which a new wall evidently begins. This new wall is evidently a lean-to to the remains of the old one, and would seem to be of a different date. Close by here are the buildings marked "Tomb" on the plan (fig. 1), and these somewhat interfere with further excavating in this direction. This main wall is pierced lengthwise by a gallery or passage (fig. 5), which is perfectly preserved, and opens off the sea-beach with a substantial doorway. This passage is 6 feet high and 4 feet

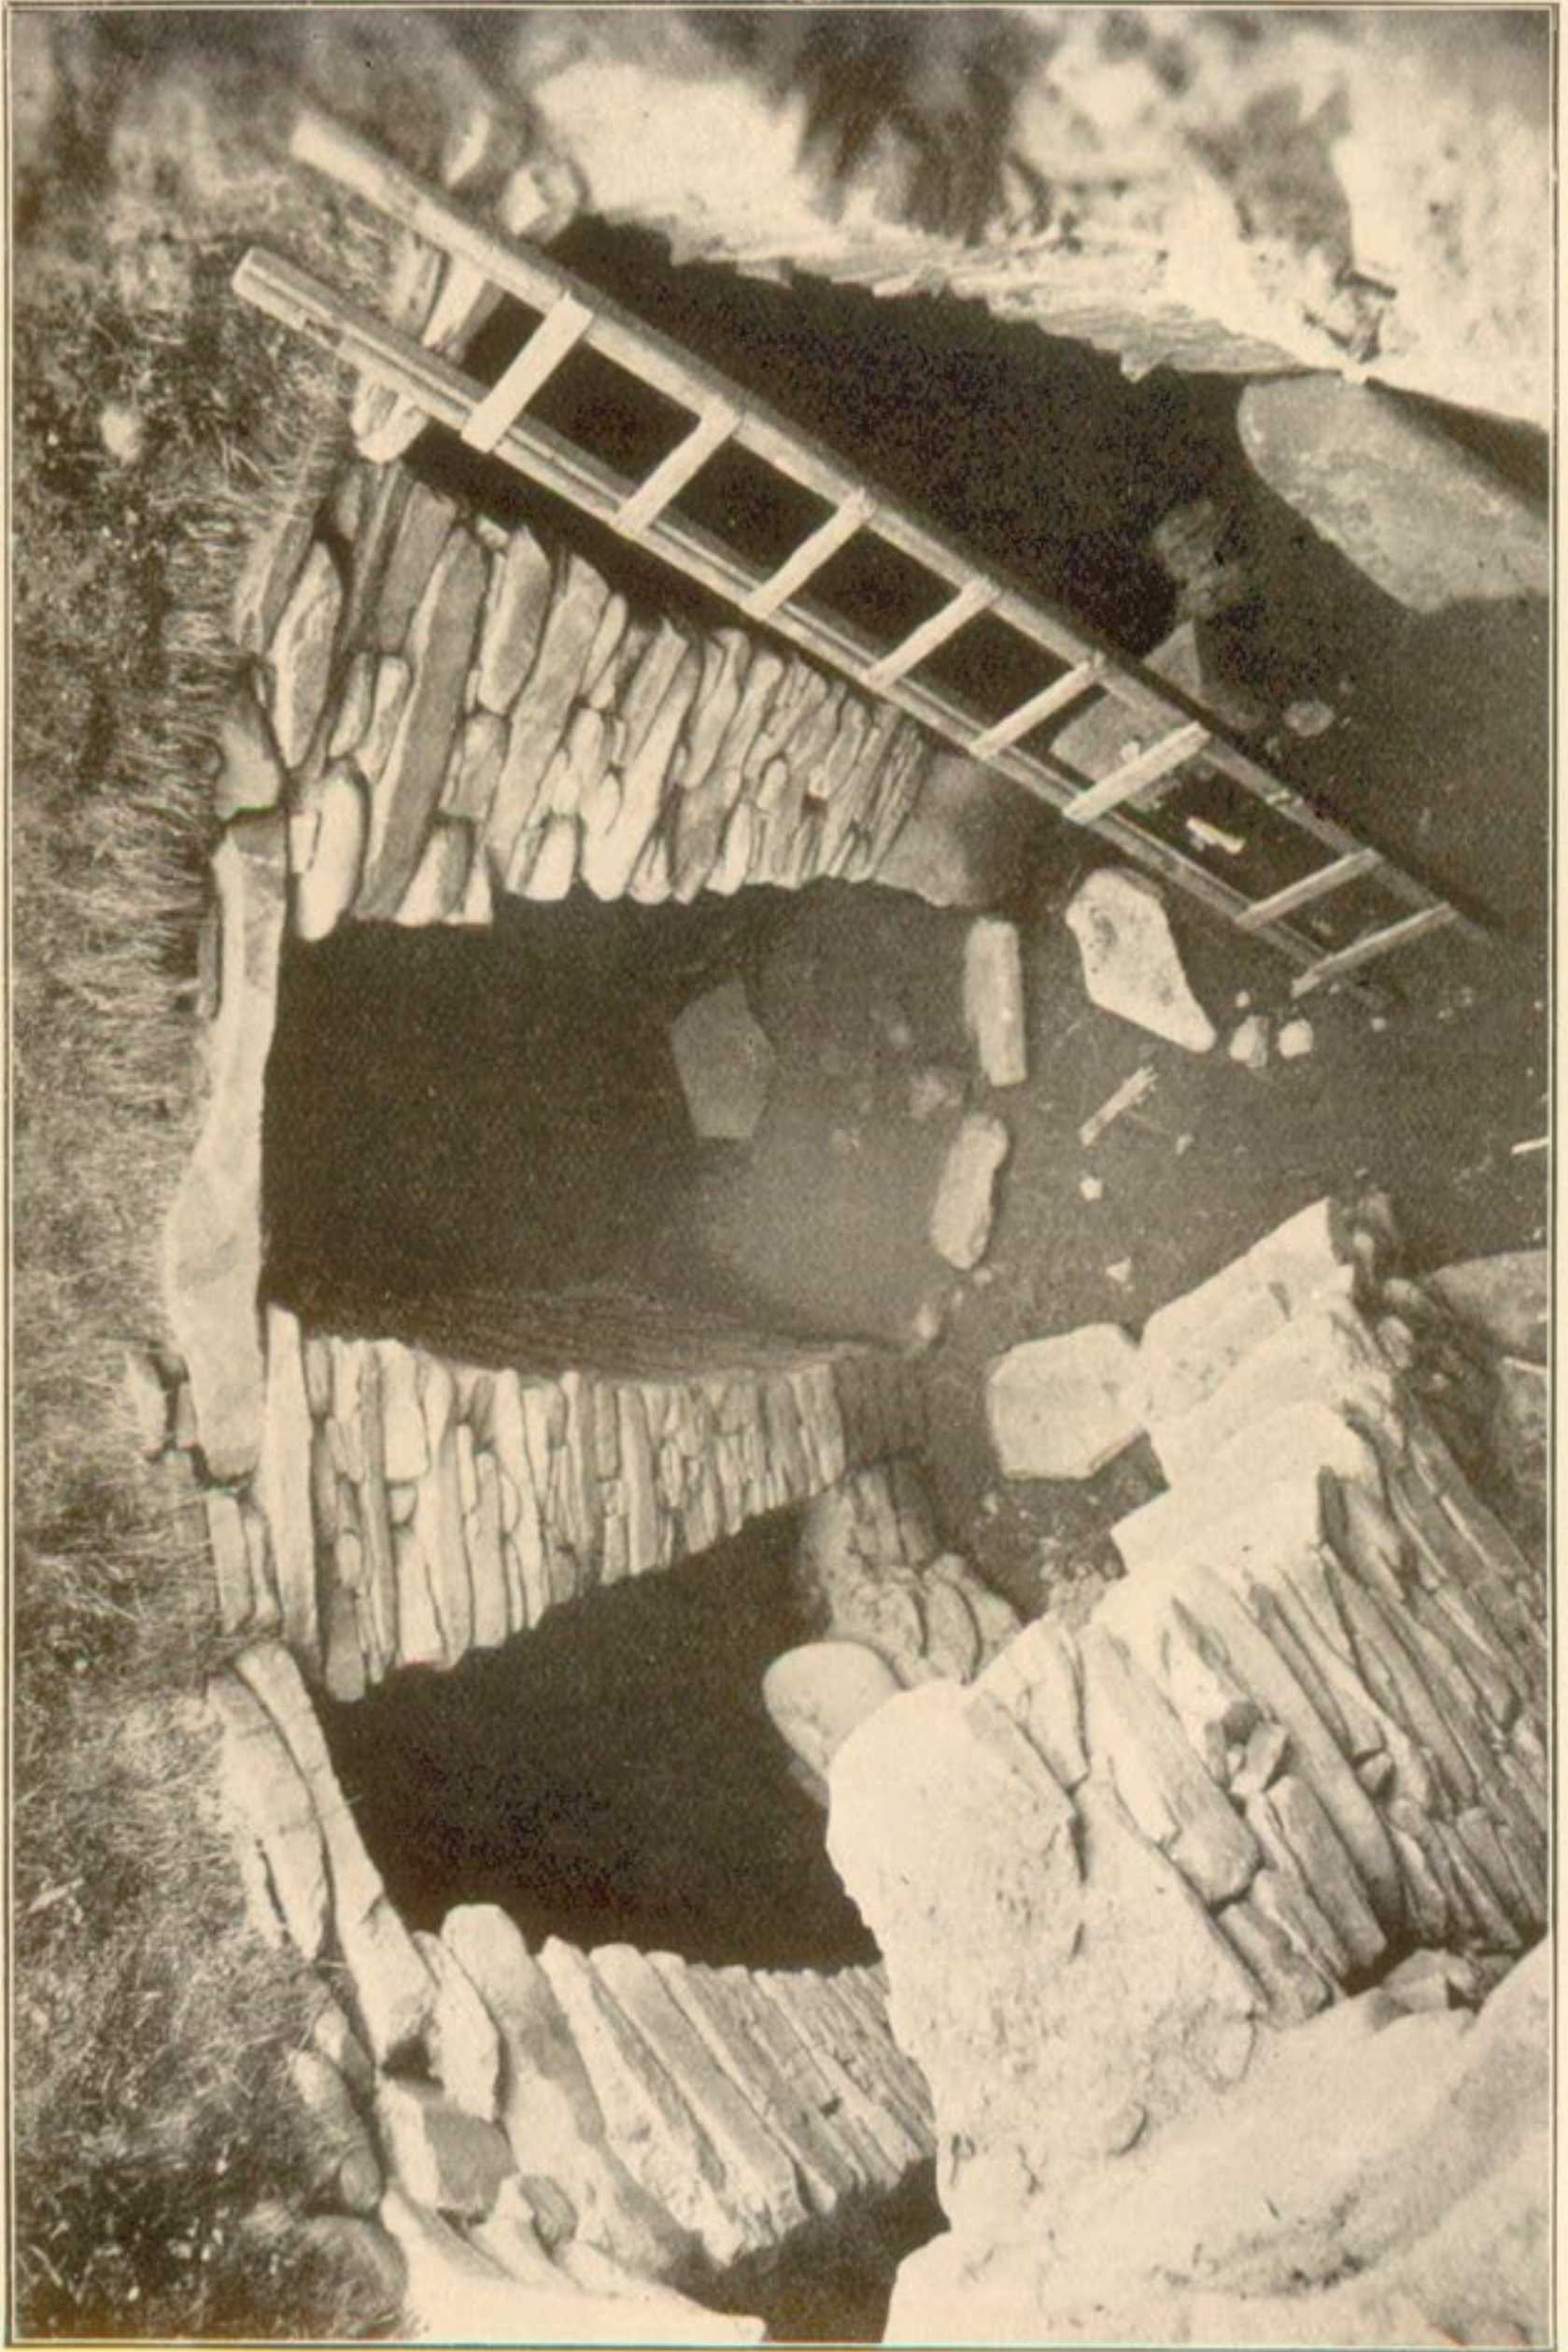
Fig. 6. Beehive Structure, looking down from north. (No. 2 B on plan.)

wide, roofed over by large flat stones, almost as they had at first been laid. The doorway is 5 feet high, sill to lintel, the lintel being a huge, very heavy stone, laid edgeways. It also would appear that a similar passage ran through the wall immediately above this one; but as the wall is quite broken down at this height, this is difficult to determine. This passage leads to a beehive structure (fig. 6), which seems to have been built on a bolder plan than any of the similar structures mentioned in Sir Arthur Mitchell's *Past in the Present*, as it is in very substantial proportions and very well finished indeed. This beehive is marked No. 2 on the plan (fig. 1). It is circular, of 20 feet diameter. Arching chambers are built out from its main wall; these are five in number, and their height and width mark the difference between these and the buildings found on the east side of the broch and elsewhere. These chambers are all regular in height, being 11 feet high, but slightly irregular in shape and size. They are, of course, somewhat triangular in shape, the entrance being about 5 feet and the wider back part from 7 to 9 feet. The chamber in which what appears to be an oven is placed is rather larger than the others. They are each arched like a beehive in the roof, of beautifully built overlapping stones, the centre gradually closing till it is covered by one single stone, evidently about 3 feet or 4 feet square. Possibly the centre of the whole was covered in like fashion, but there is nothing much to indicate that now.

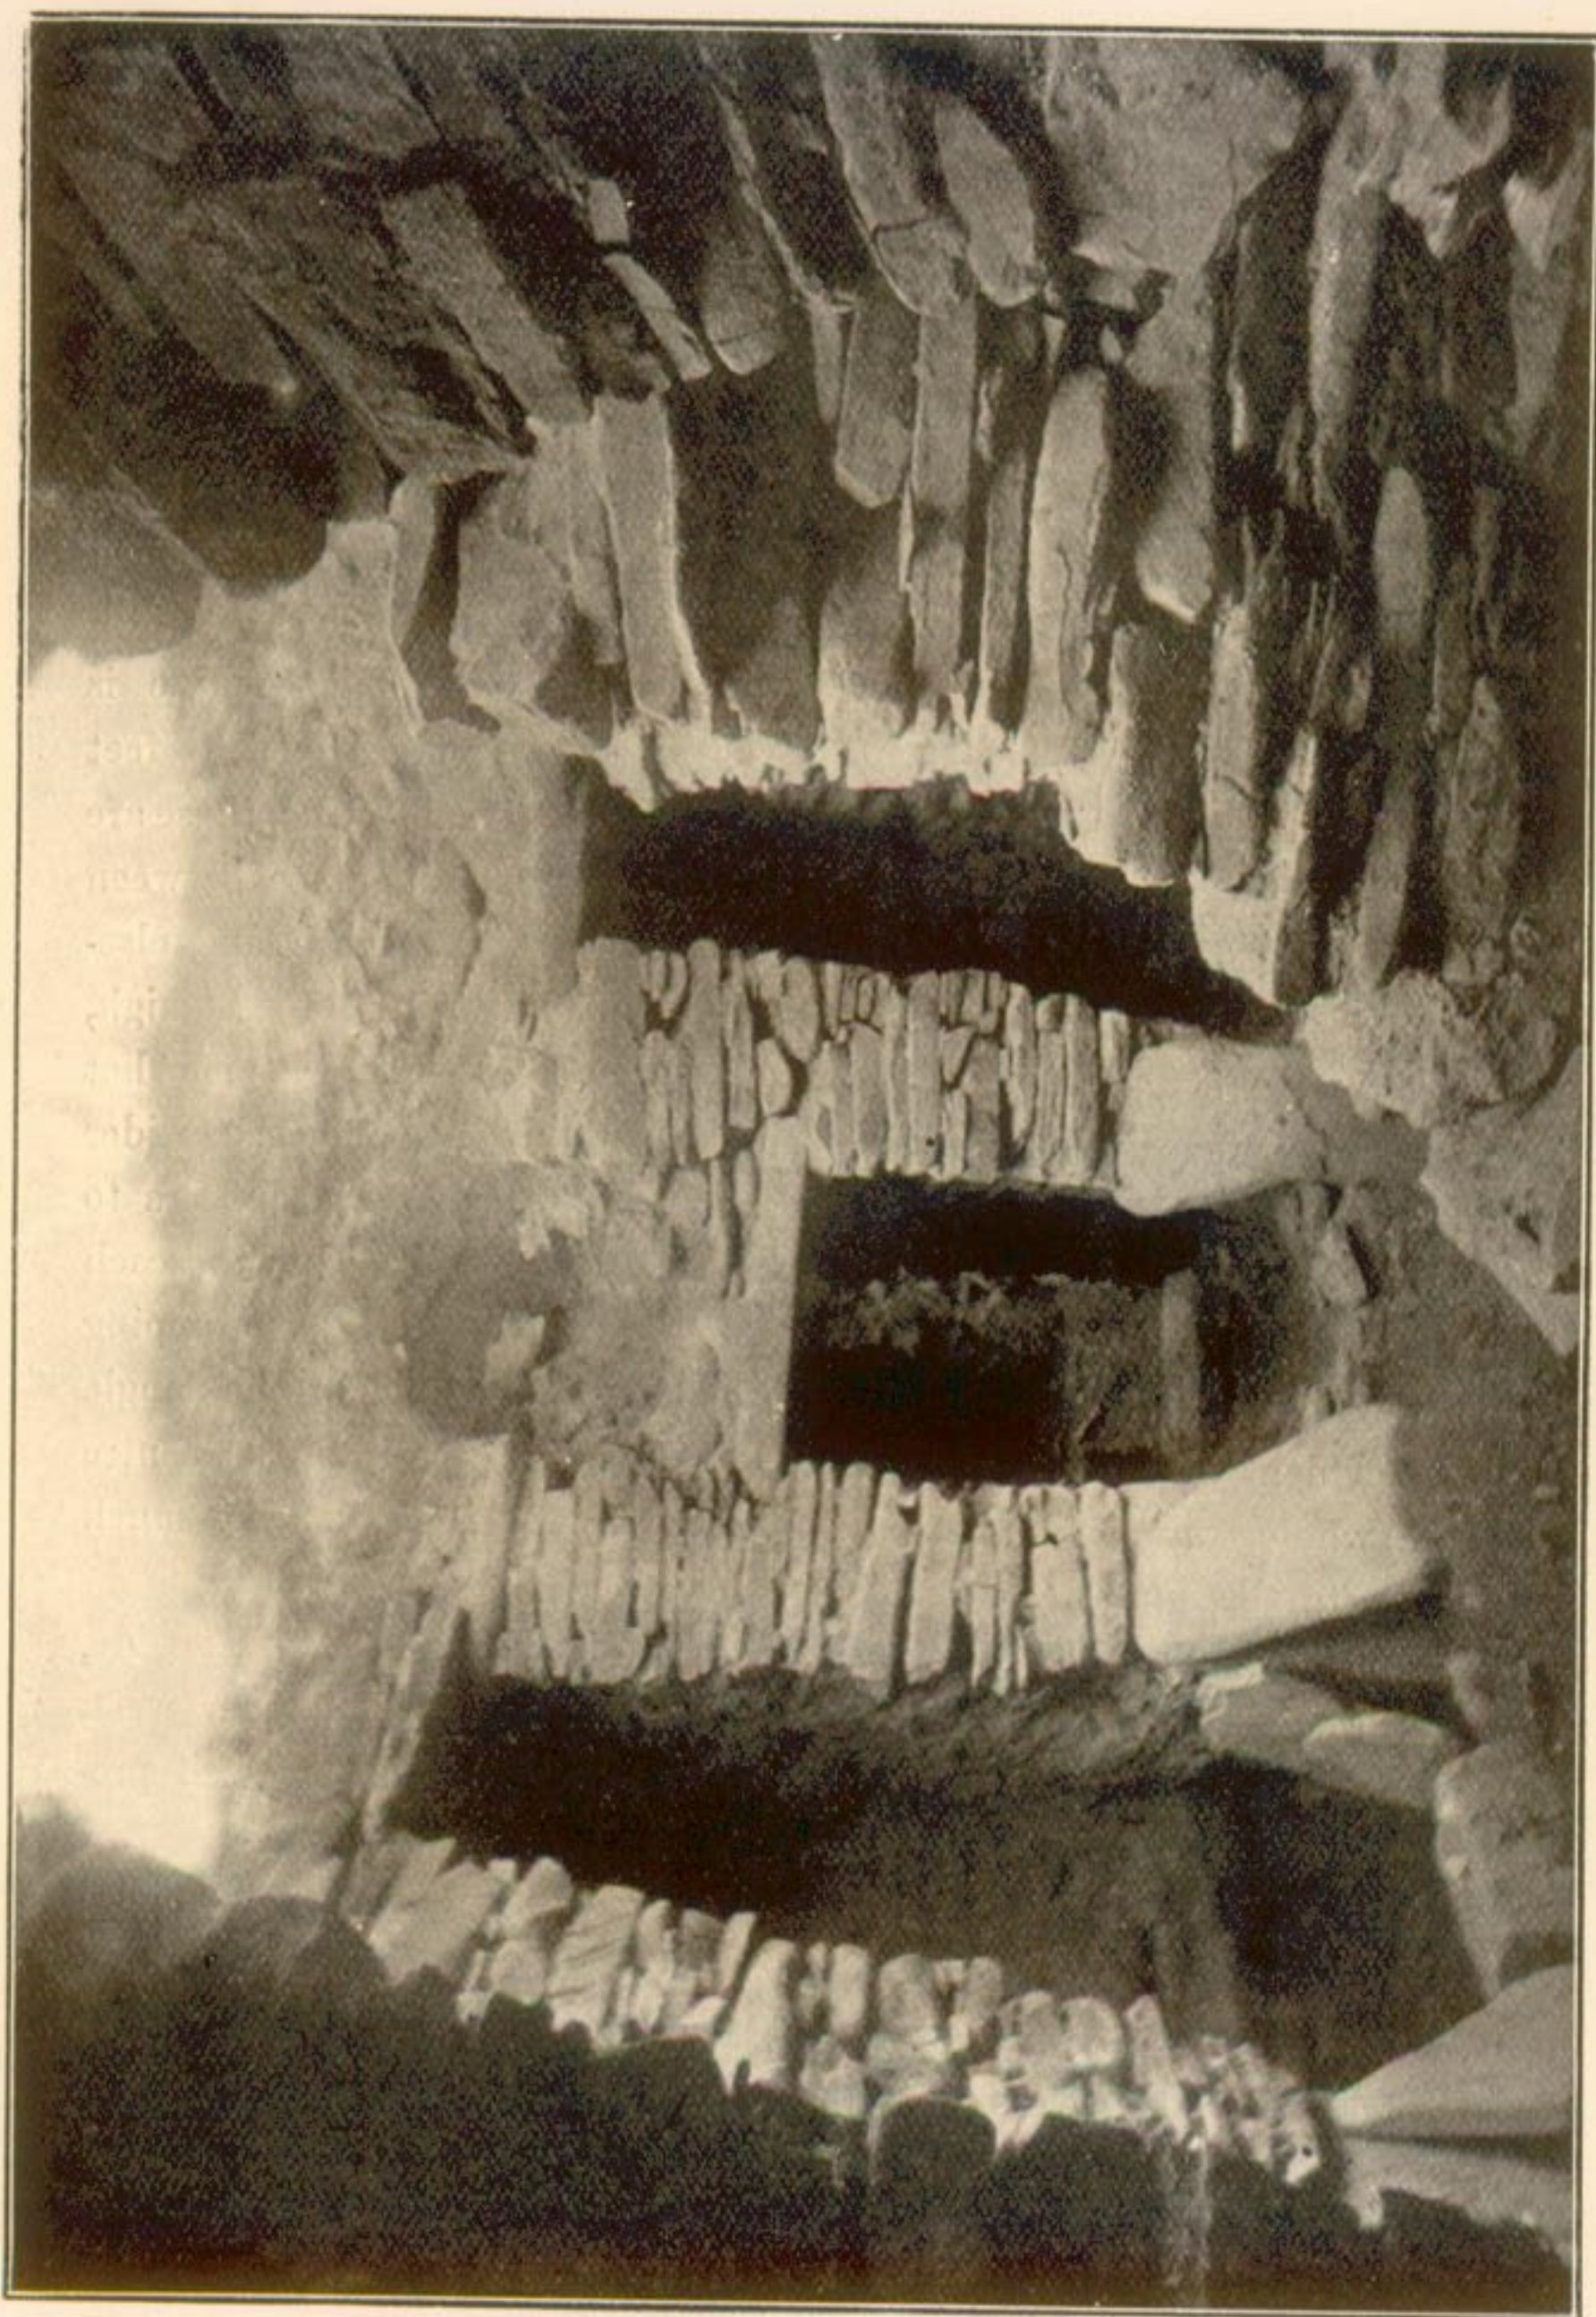
Fig. 7. Doorway of Passage leading from Beehive No. 2 to Beehive No. 1. (No. 2 A on plan.)

A substantial doorway (shown in fig. 7), 5 feet high and 3 feet wide, leads through the great main wall to a similar structure further west, marked No. 1 on the plan (fig. 1). This, however, is not so well preserved, and evidently of less imposing dimensions.

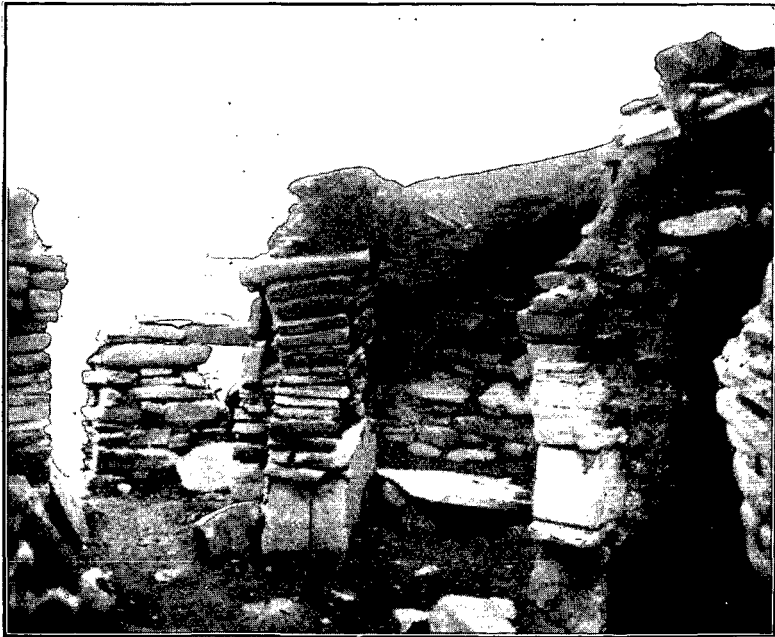
Fig. 9. Large Beehive Structure (No. 3), looking from east.

Nearer the sea, and forming the inner face of the main wall, is another beehive structure (fig. 9), which is marked No. 3 on the plan (fig. 1). It, again, is much larger than that marked No. 2 on the plan,

but it is not so well preserved, and is damaged at one end by the sea. The roofs and part of the wall are also destroyed; at one part it was found necessary to build a buttress to hold up the wall. Its highest point is 8 feet and it is rather oval in shape, being 34 feet long and 19 feet wide. It also has five chambers, more or less triangular in shape, and differing slightly in size, the largest being 5 feet 6 inches at front and 10 feet

6 inches at back. Unfortunately the roofs of the chambers are gone. Some big slabs of stone over 4 feet long and 3 feet wide show that the roofs have been made in the same way. It was also necessary to strengthen various parts of this by facing the rough side of the single wall with stone in order to prevent its total collapse when the earth on both sides was removed.

The bases of the piers, which form the alcoves in the secondary constructions, and which support the overlapping stone arrangement by which the roofing slabs are held, are of a peculiar construction. The base of the pier is faced with an upright slab, resting on this is a horizontal slab bonded into the wall, the end of this slightly projects beyond the upright stone. Dr Anderson alludes to this kind of construction.² It is unfortunate that in fig. 7 this feature is hidden by loose slabs resting against the piers, but the arrangement is well shown in fig. 9.

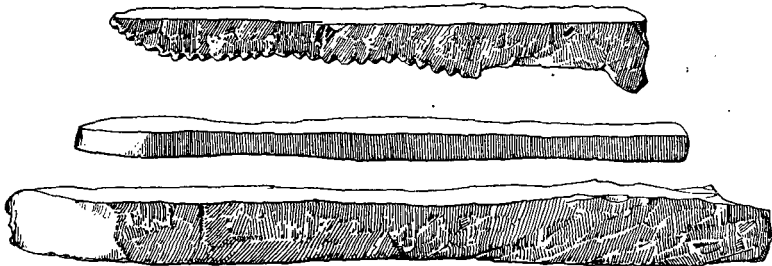
Fig. 10. Stone Saw and two Stone Implements, chisel-ended. ($\frac{1}{2}$.)

In a little cupboard in the wall of No. 3 beehive were found two stone tools, one a saw, 12 inches long (fig. 10), and another thin stone of similar length, with a line cut across the middle and two lines close together about 4 inches from the centre on each side.

Two long stones, shaped like small crowbars (fig. 10), were also found; they are chisel-shaped at one end, but what purpose they served seems difficult to determine.

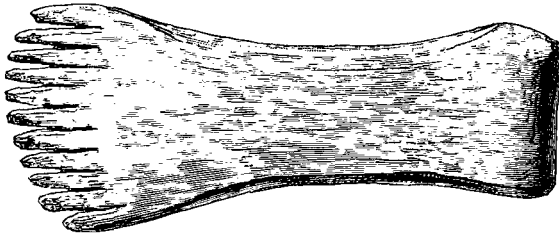
Fig. 11. Long-handled Weaving-comb of bone. (§.)

Besides these stone implements were found many querns and rubbing-stones, both whole and broken, and portions of stone vessels, many whorls for spinning (one made of clay), and a long-handled weaving-comb of bone (fig. 11) similar to those so often found in brochs.

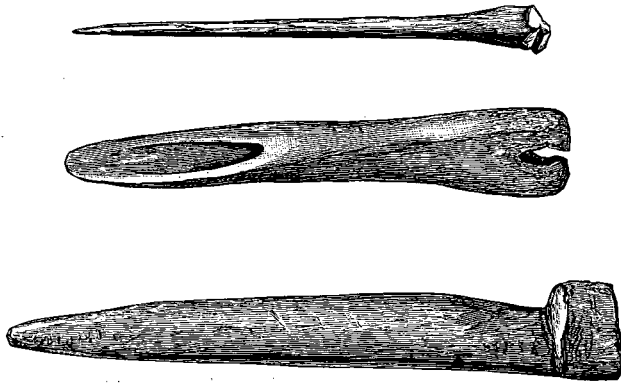
Fig. 13. Bone Implements. (3.)

skewer-like instrument, an instrument made of a leg-bone of a sheep, ground to a flattened form slantwise at one end, a peg-shaped implement with a roughly cut notch near one end (fig. 13), and portions of vessels

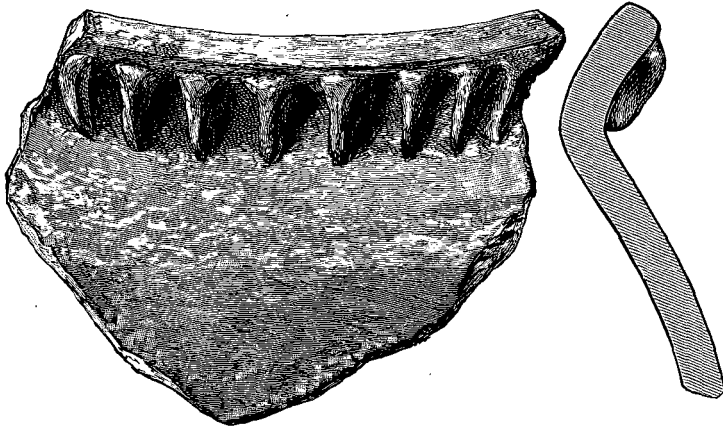
Fig. 15. Portion of Pottery Vessel with buttress-like ornament. ($\frac{2}{3}$.)

It seems surprising that very little pottery of any kind was found, except in small fragments. Only one piece has any definite shape, and has evidently been a portion of the upper part of a vessel at least 6 inches in diameter, with a broad everted lip,

bordered on the under side by a bold buttress-like ornament, as shown in fig. 15.

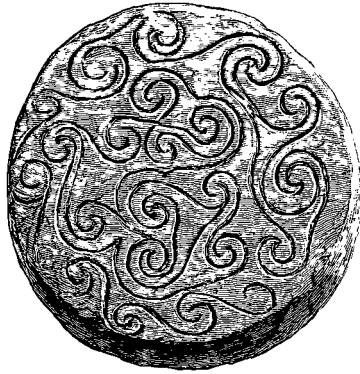
Fig. 16. Disc of Sandstone, with Pattern of diverging Spirals.

differ from the larger roughly-chipped discs or pot-lids previously described, as they are somewhat thicker in proportion to their diameter, and they have smooth surfaces and edges; also they are of a more uniform size, say $2\frac{3}{4}$ inches. One of these, made of a reddish sandstone, has engraved upon one surface Celtic diverging spirals, similar to those on the monumental stones at Hilton of Cadboll and Shandwick (fig. 16). This peculiarly Celtic decoration is known to have been used in the ninth century A.D., which may well be the date of these secondary constructions.

Other discs of sandstone, of smaller sizes, were well finished. One has on it a strange design, well cut, on one side; and another has, deeply scratched, two lines crossing each other at right angles.
